RAAI project: new concepts for corrosion-fatigue assessment of axles

Corrosion assessment on axles

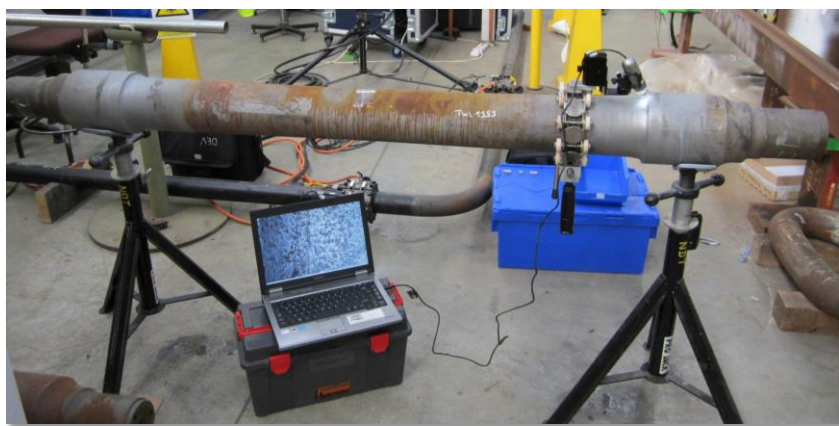
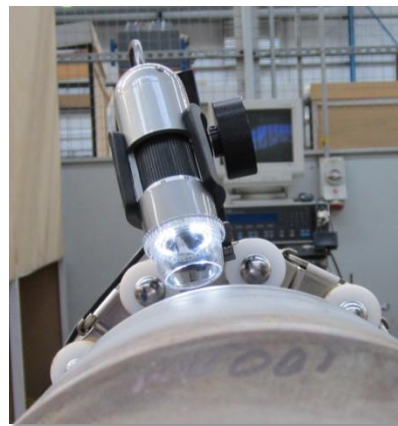
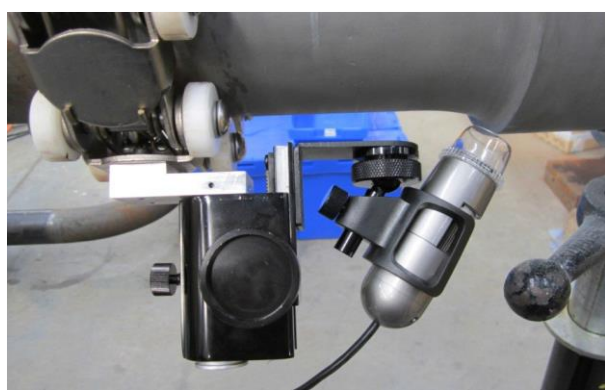
Wolaxim prototype

- Special holder developed to enable controlled movement of the microscope in both vertical and angular direction
- Robust scanning system
- Use of instrument around the axle circumference
- Battery operated (laptop)

Problem with the prototype system

- Scanning large area OF AXLES inefficient manually
- No axial movement of scanner
- Manual data collection (individual shots)
- Limited analysis

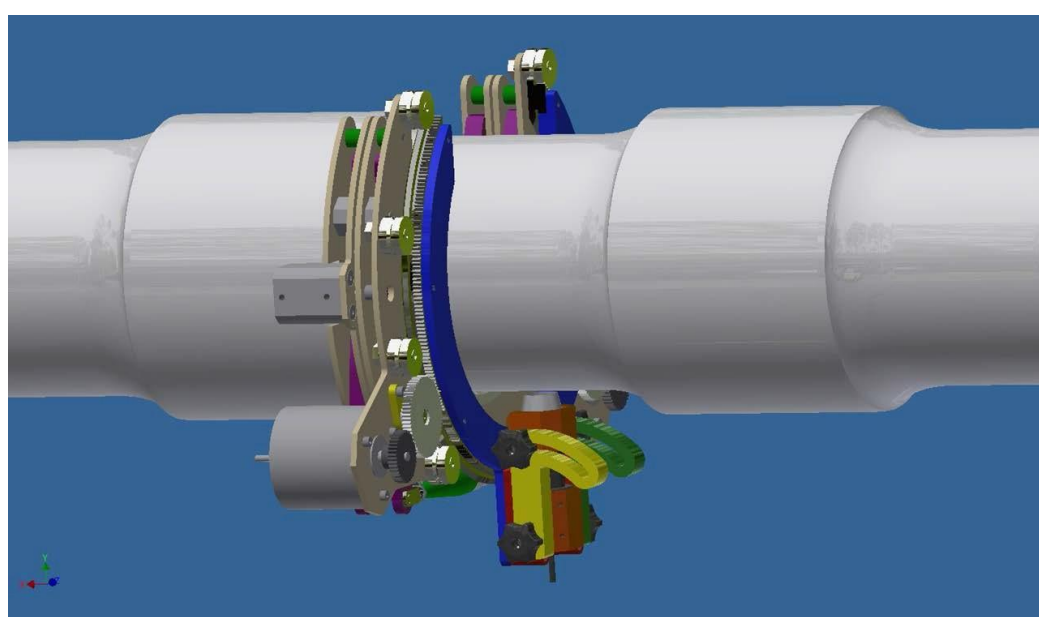
New scanner

- Automated scanner
- Improved data collection
- Image analysis
- Automatic sentencing
